BILLINGS

A CONTINUING PLAN
FOR TRAFFIC OPERATIONS

PLAN FOR TRAFFIC OPERATION IMPROVEMENTS 1970-71

MONTANA DEPARTMENT OF HIGHWAYS
PLANNING RESEARCH BUREAU

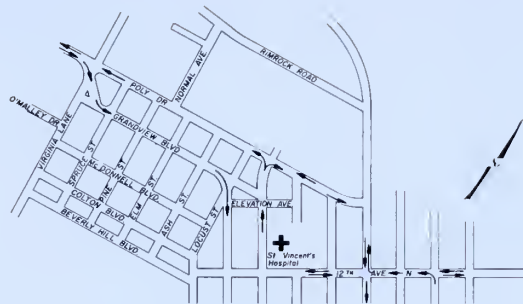
FIGURE 17

AREA I

PLAN A - CIRCULATION

*Alternate Plans - During the course of the study several alternate plans were proposed for the downtown circulation of traffic. Alternates A, B modified and C shown by Figures 17, 18 and 19 were studied but none were officially adopted by the local governments.

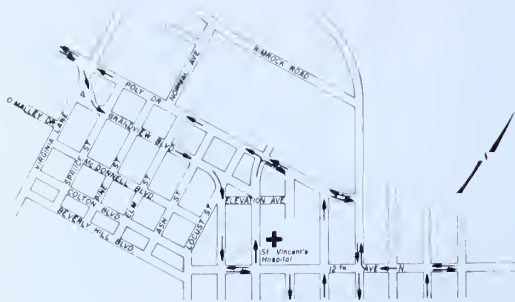
FIGURE 18

AREA I

PLAN B MODIFIED-CIRCULATION

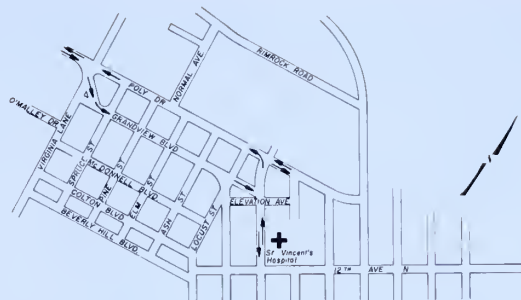
AREA I

PLAN C - CIRCULATION

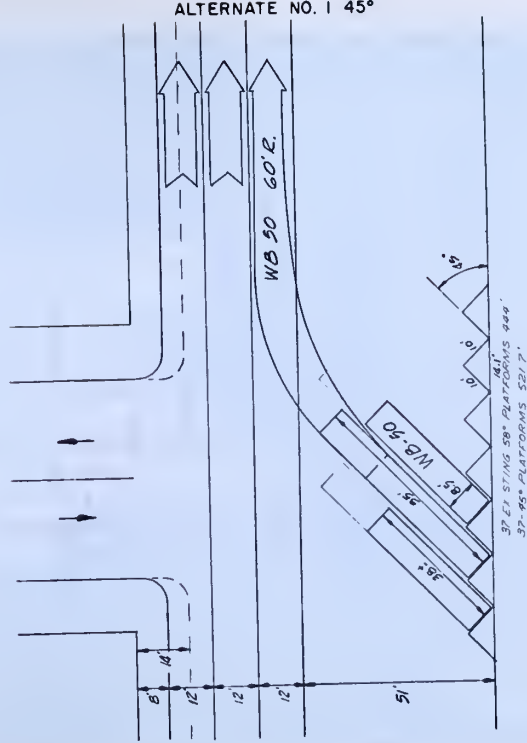
AREA I
TRUCK PARKING
ALTERNATES
MONTANA AVE
FIGURE 21

The 90 degree angle parking should be eliminated by substituting parallel parking with a loss of a few parking spaces. The partial blocking of Montana Avenue during the parking of the large truck units at the freight terminal is a difficult situation. It is possible that a traffic control could be placed to restrict the parking maneuvers during peak hours or that the angle of parking could be reduced to lessen the encroachment on the traffic lanes. Figure 21 presents one possible solution, however, we recommend a separate study of this particular situation since it involves negotiation with the Burlington Northern Railroad Company.

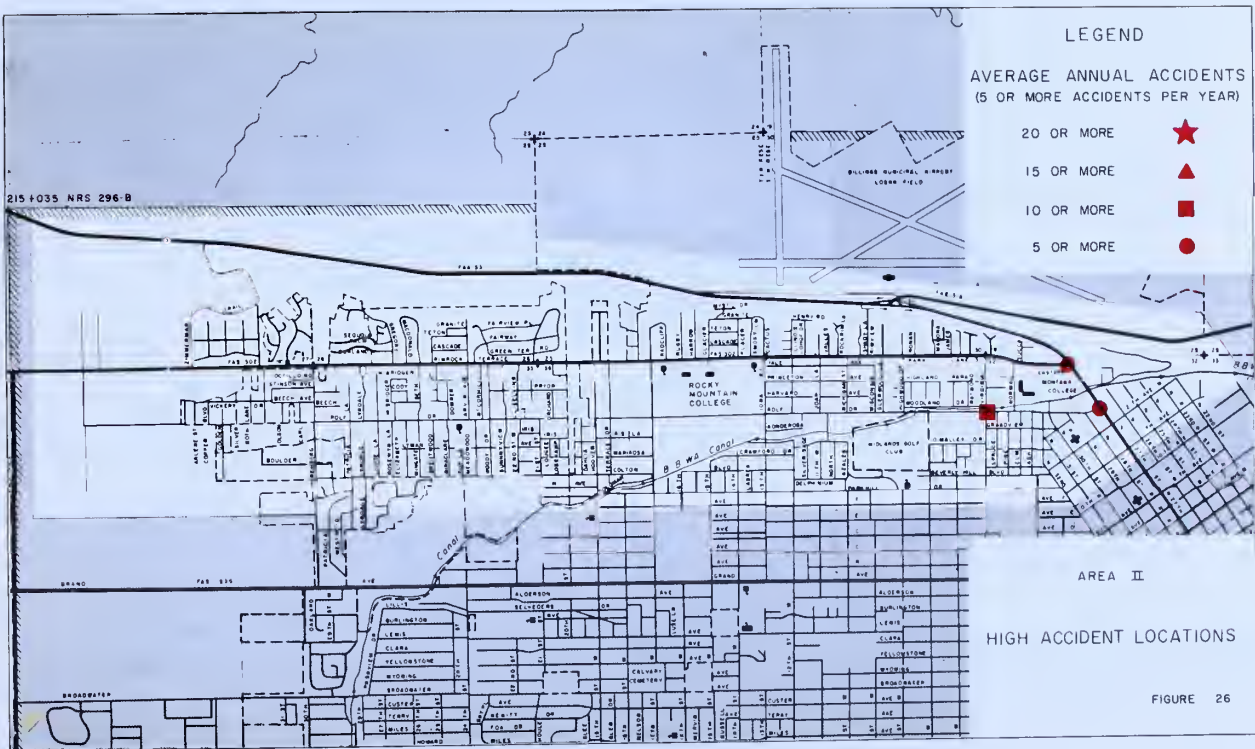
Recommended Improvements - Since warrants for signals are present and due to the poor geometrics of the existing intersection, it is proposed that the signals be updated making provisions for the one-way couplet and also including an all-red clearance interval that will prevent cross traffic from entering the intersection until other movements have cleared. The design should also incorporate provisions for the leading left turn as depicted on Figure 28.

Evaluation - These improvements will increase the capacity an estimated 30 percent and provide a safer terminus for the one-way couplet. Accidents are expected to decrease approximately 40-50 percent by eliminating the simultaneous movement of traffic that can now occur under existing conditions.

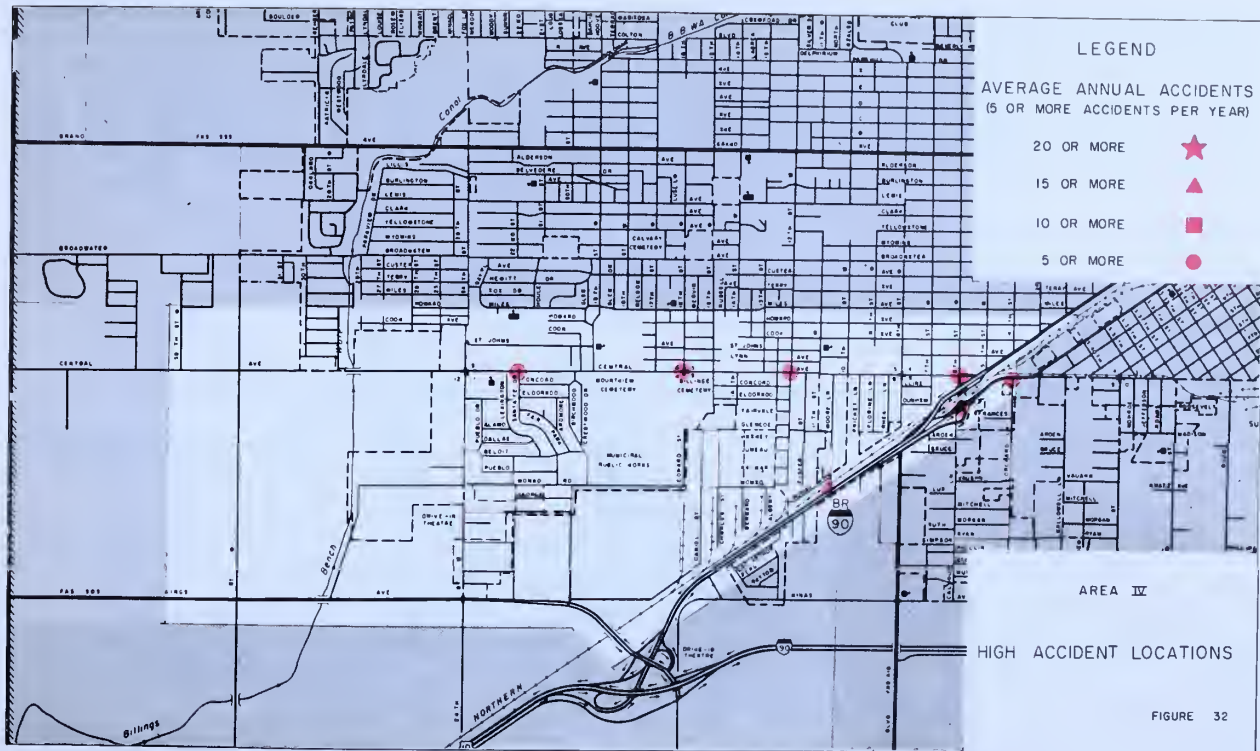
FIGURE 32

Recommended Improvements - Since adequate warrants for signalization exist, it is proposed that improvements consist of an increased turning radius for the east to north movement, a wider at-grade crossing and a signal system that would include a railroad preemption preventing traffic southbound on Moore Lane from storing on the railroad crossing. The plan also provides for a storage lane parallel to the westbound lanes on U. S. 10. The storage is intended for those units that must wait during a railroad preemption phase and presently block the thru traffic lane.

Evaluation - The improvement is intended to provide a safer crossing and should reduce the number of vehicular accidents considerably. The hazard involving train movements should also be greatly reduced.

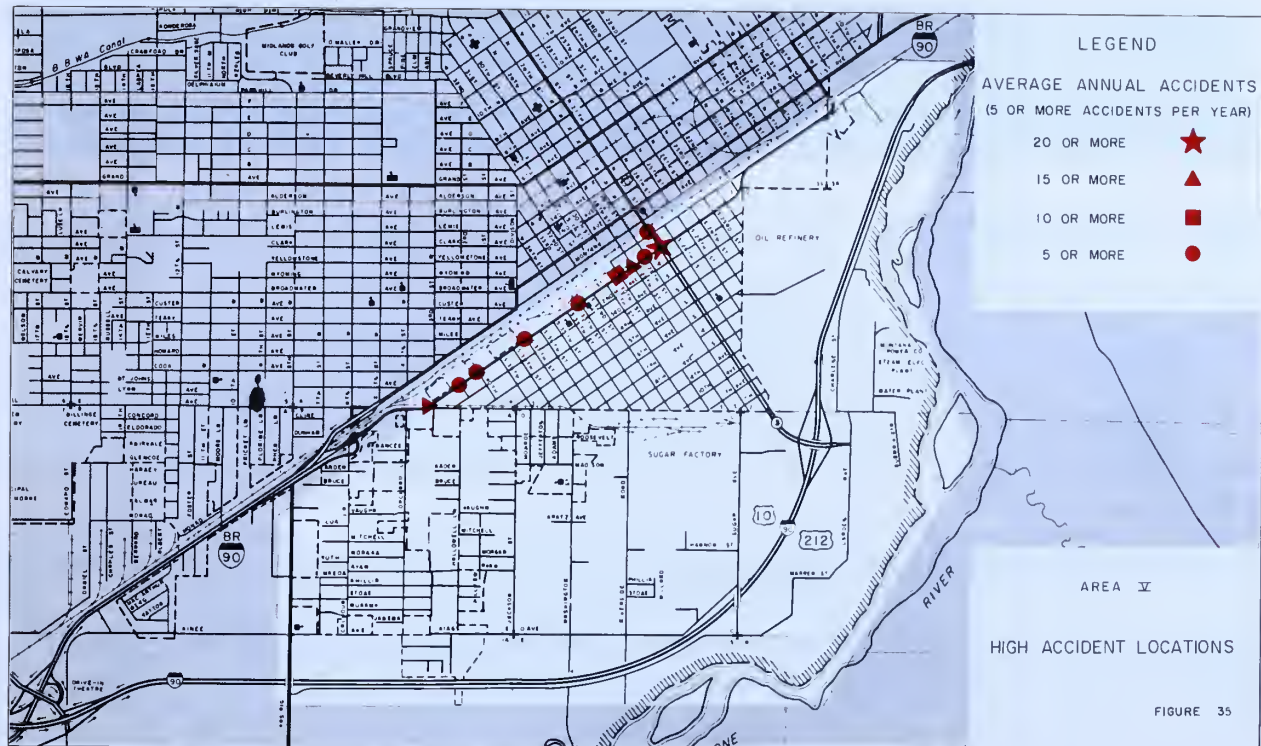
FIGURE 35

Recommended Improvements - Other than a recommendation of major reconstruction to improve the surface and roadway width, no major TOPICS type projects are evident. Minor improvements are indicated on page 199 and 201 of the improvement section.

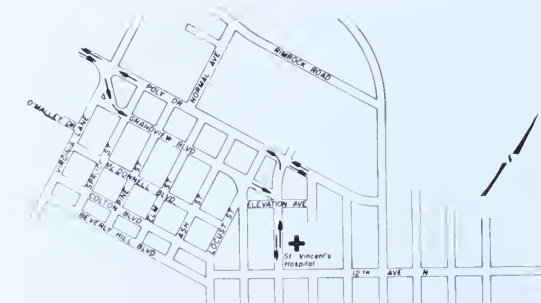
AREA I
LONG RANGE PLAN
(GRUEN)

FIGURE 20

North-south one-ways have been extended to Division Street on the west and to North 24th Street on the east. This is a preferred situation since it provides more continuity to the one-way system and lessens driver confusion.

Twenty-seventh Street will remain as a two-way major arterial until the structures on North 25th and North 30th Streets become a reality. The recommended improvements on North 27th Street contained in this study should provide mobility to the system during the interim period while the long range plan is being developed.
